EKSPAN BEARING INSPECTION REPORT 2012 AND 2019 ESTIMATE

----- Original Message -----

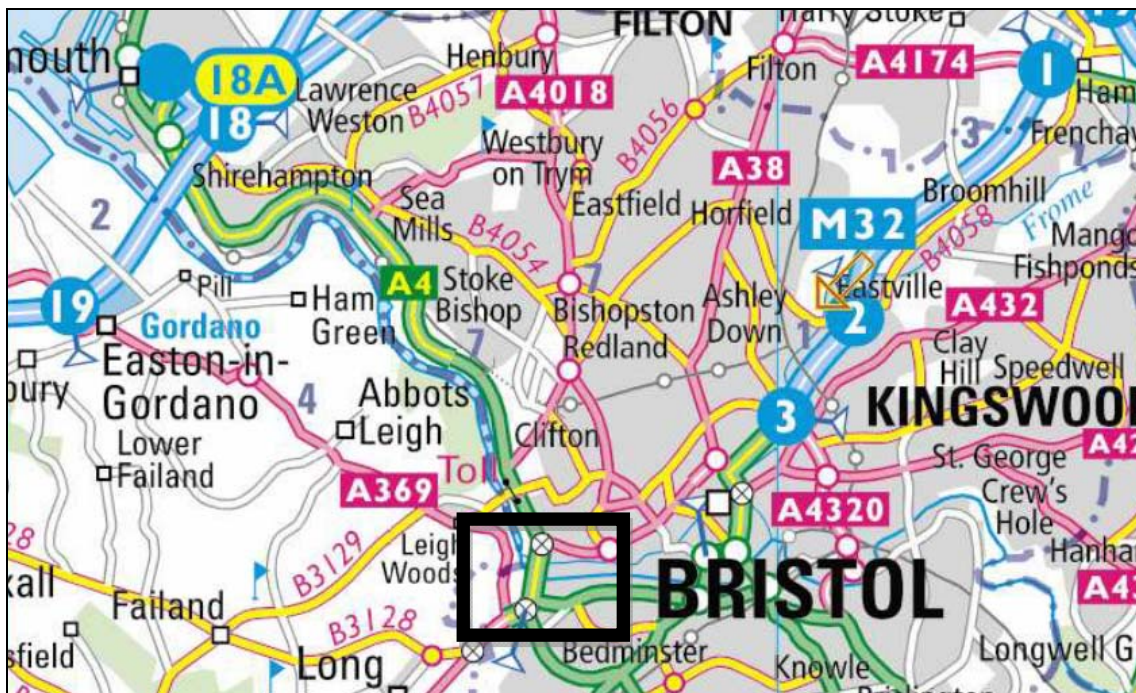
The structures were located to the south west of Bristol city centre.

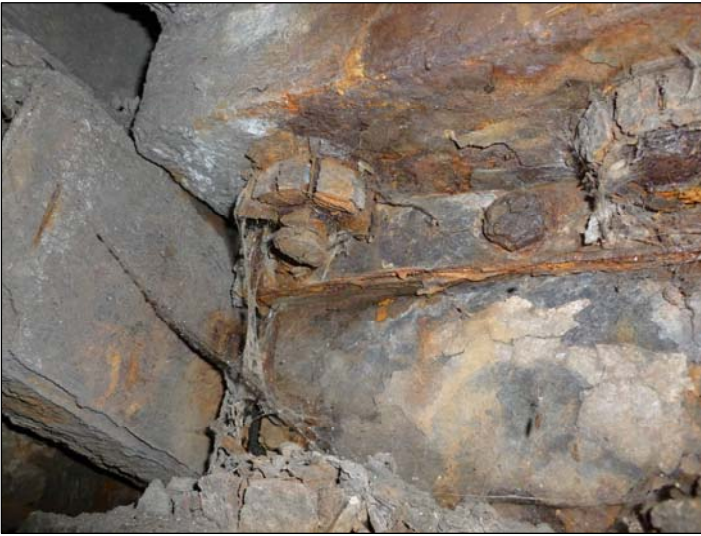
Bearing B2;
Loss of section to nut of bearing B2 top plinth which is common to all bearings across the pier.

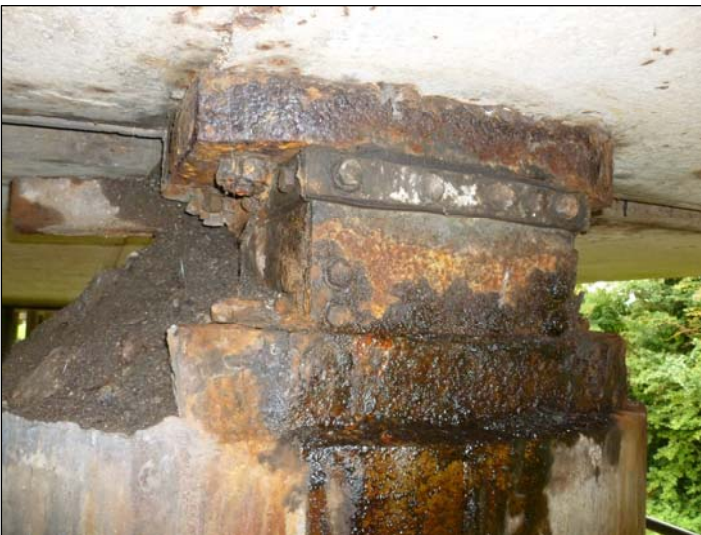
Bearing D1;
Heavy corrosion to grease box and steel plinths is common across the pier. There was a large amount of grease leaking from the box at this location.
There was a large dirt/debris build up to column D between the two bearings, of which most was removed to remove grease box.

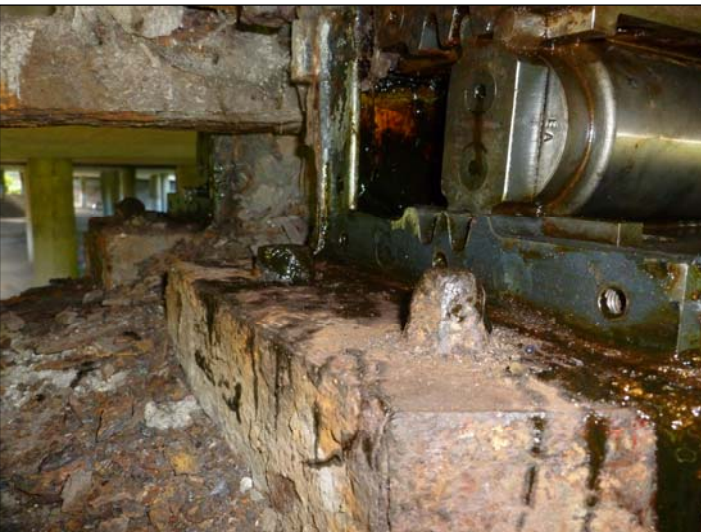
Bearing B1;
Loss of section to nut of steel plinth.

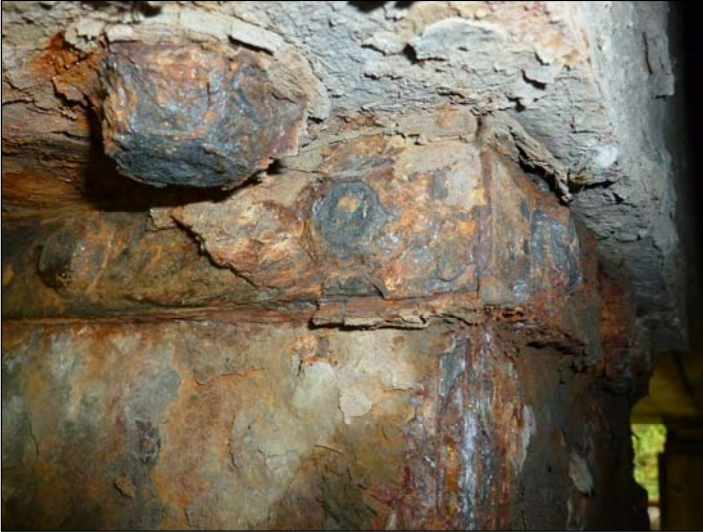
Bearing A2;
Delamination of steel and corrosion to bolts made it difficult to remove the sides of the grease boxes.

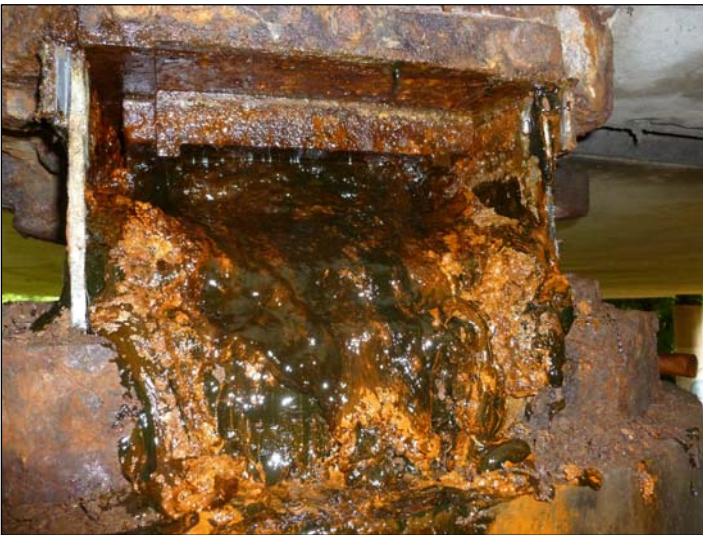
Bearing D2,
There was a large amount of water came out of bolt holes of the grease boxes upon removal at C2 & D2. Here at D2 to you can see the condition of grease upon the removal of the box.

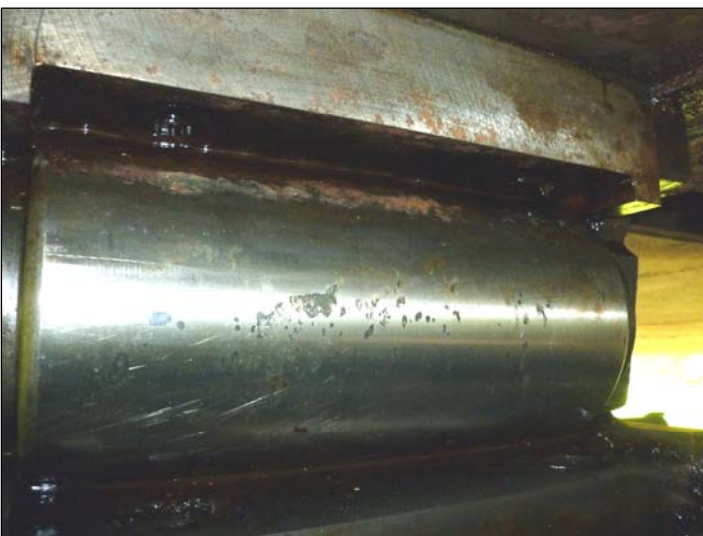
Bearing C2;
Typical condition of rollers at pier 13.
Minor surface pitting is common across the surface of the rollers.

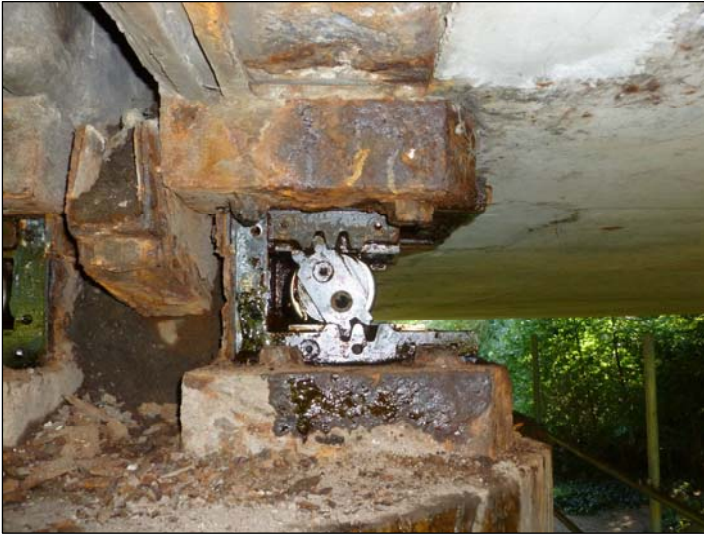
Bearing D1;
This is the largest rotation to a guide on the structure.

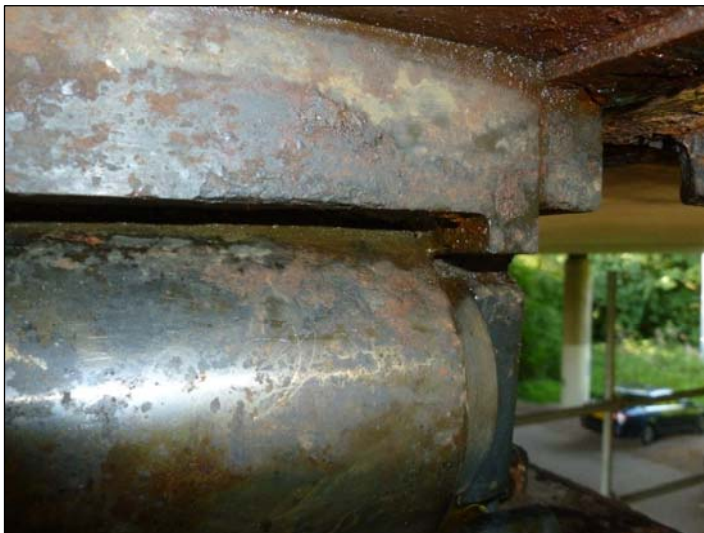
Bearing A2;
The roller to bearing A2 is in the worst condition of the 8 at pier 13. There is more pitting to the surface and surface corrosion mostly across the top of the roller, this may be due to reduced cover from grease.
Also note the surface corrosion to the top plate.

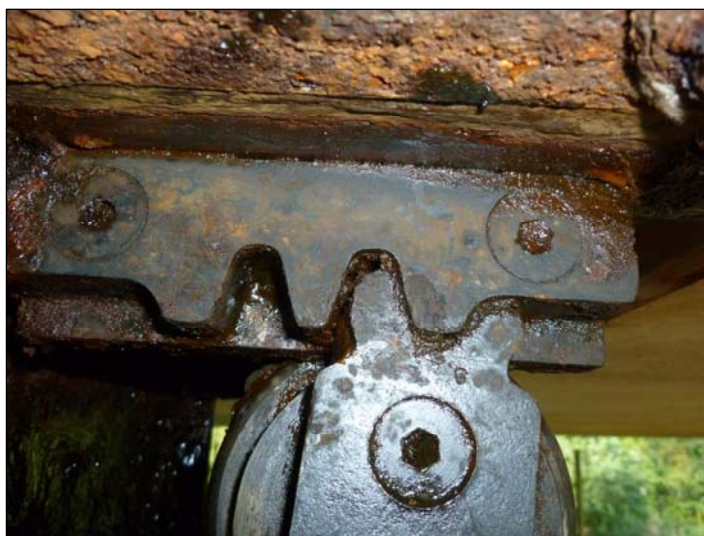
Bearing A1;
Pitting and surface corrosion is common to the upper elements of the guide arrangement.
Also note how the roller guide has been set on the wrong tooth.

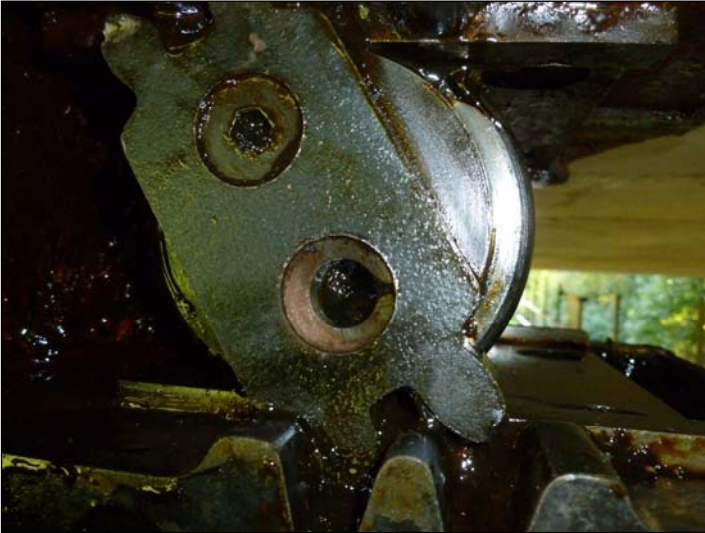
Bearing D2,
Missing fixing to south guide of bearing.
The missing fixing was not found during
removal of grease so it can be assumed
that there was never a fixing attached.

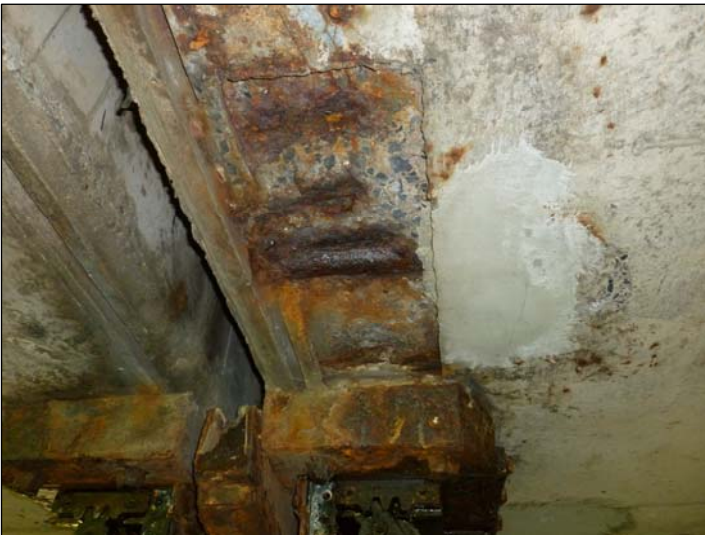
Bearing D2;
Failed repair to deck soffit adjacent to
joint exposing reinforcement to the
south of bearing D2.

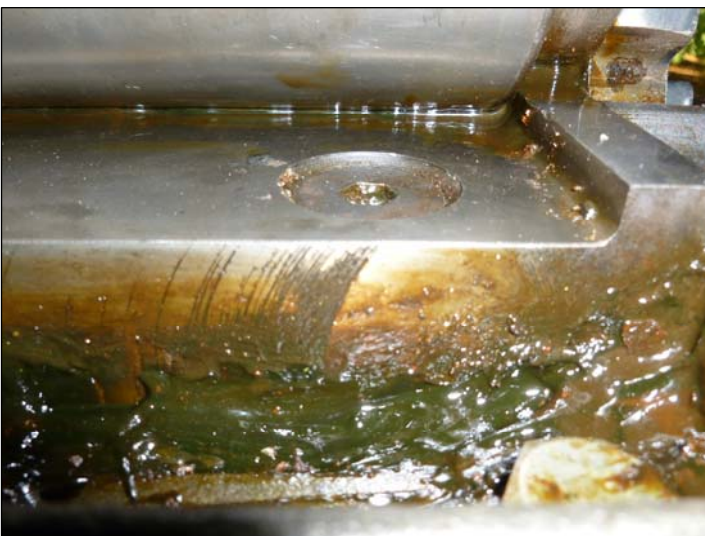
Bearing B2;
Typical condition of base plate and base
plate fixings.

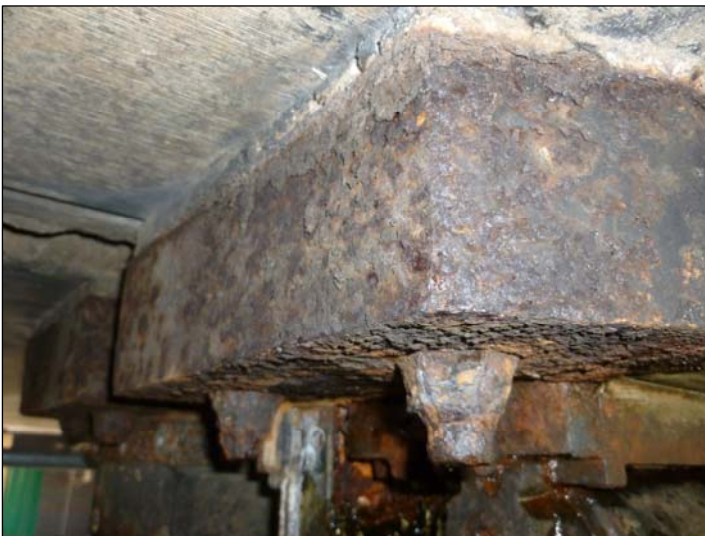
Bearing A2
Heavy corrosion to steel plinths and loss of section to nuts.

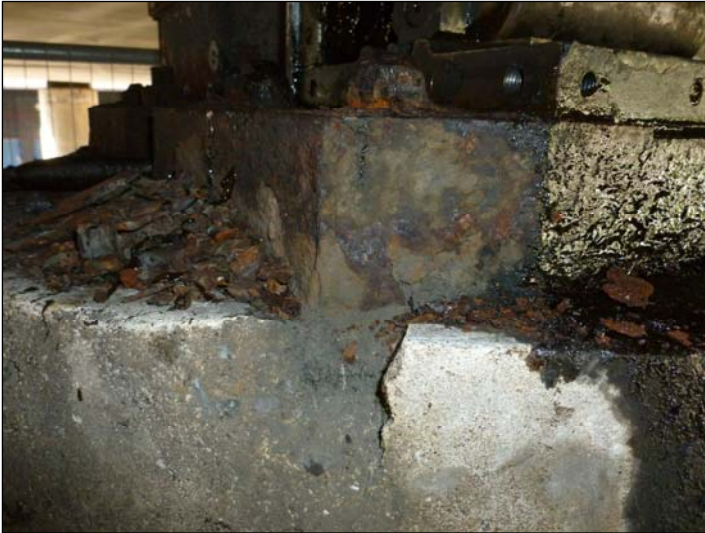
Bearing A2;
Small spall in top of column adjacent to corner of steel plinth.

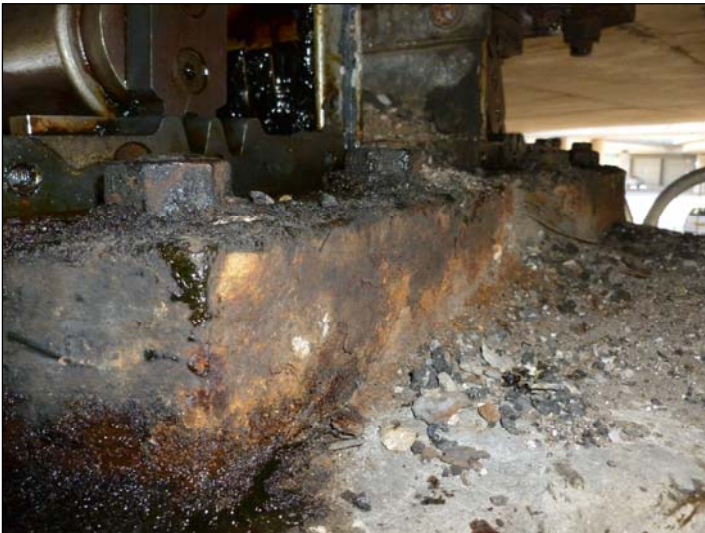
Bearing B2;
Delamination to bottom steel plinth.

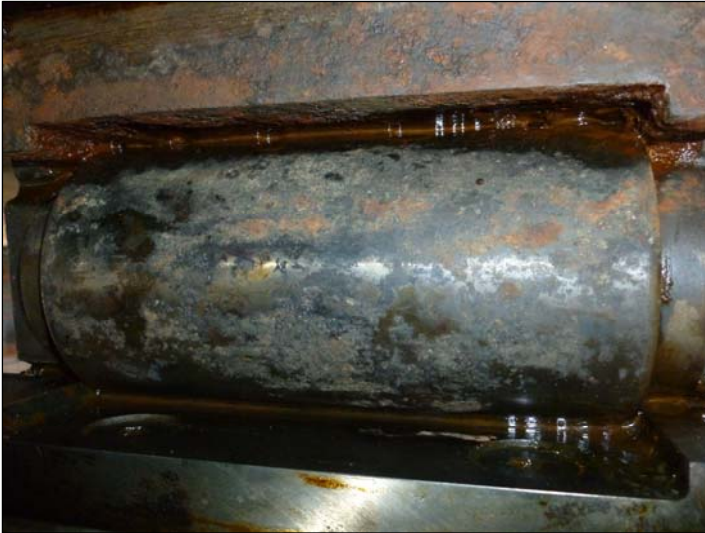
Bearing A2;
Light to moderate surface corrosion over 80% of surface of roller.

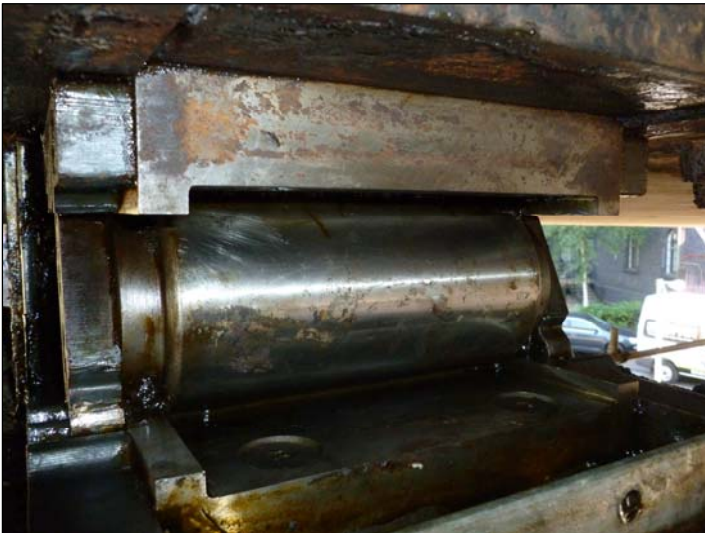
Bearing B1;
Roller to bearing B1 however is in good condition with minor pitting to surface.

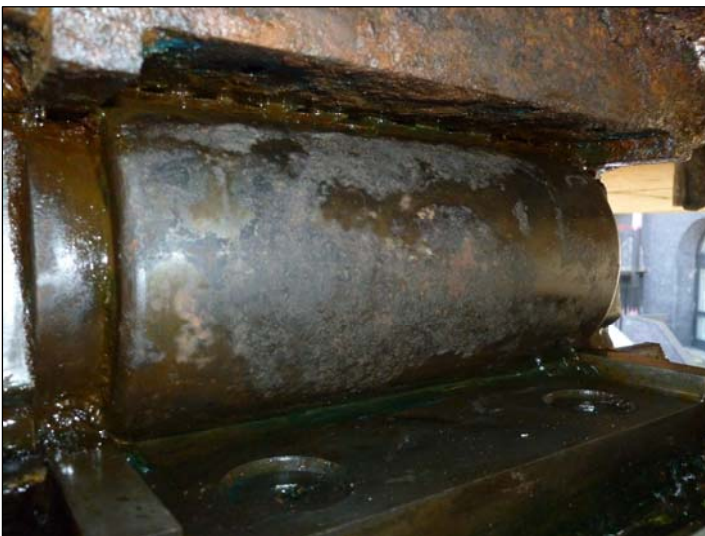
Bearing C1;
Surface corrosion over large area of roller.

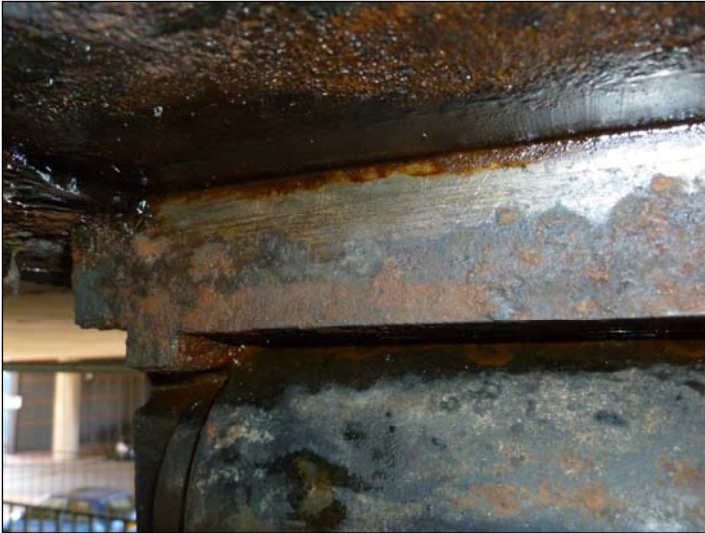
Bearing A2;
Surface corrosion along front face of top plate.

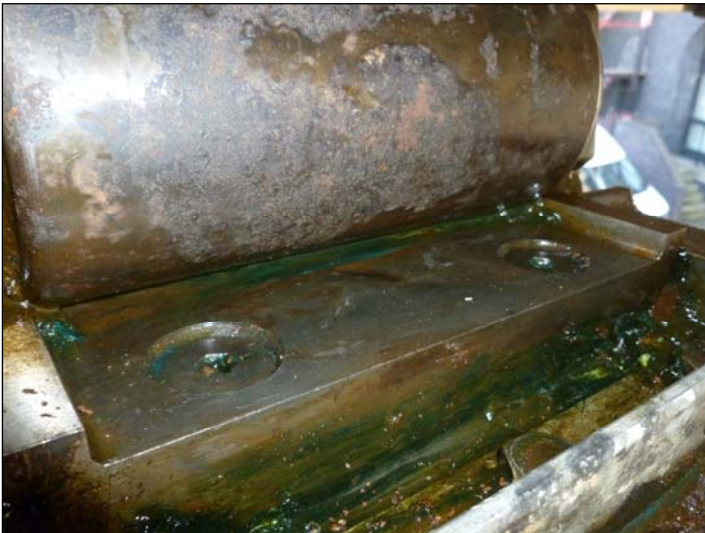
Bearing C1;
Base plate and fixings are in good condition.

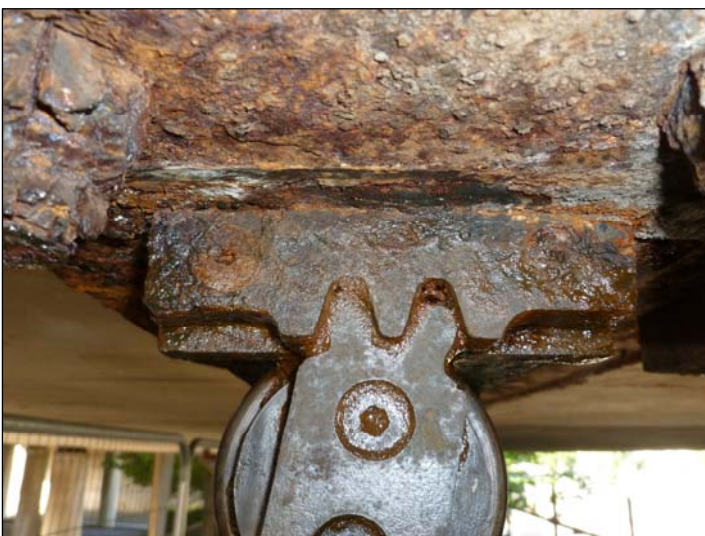
Bearing C1
Significant corrosion over surface of guide rack and some pitting and light surface corrosion to higher level of roller guide.

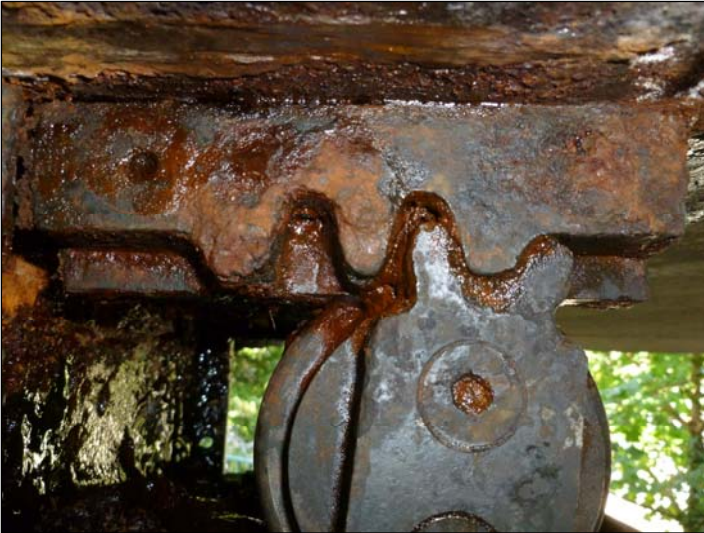
Bearing A2;
Again, corrosion to guide rack and roller but also the guide appears to have been set on the wrong tooth.

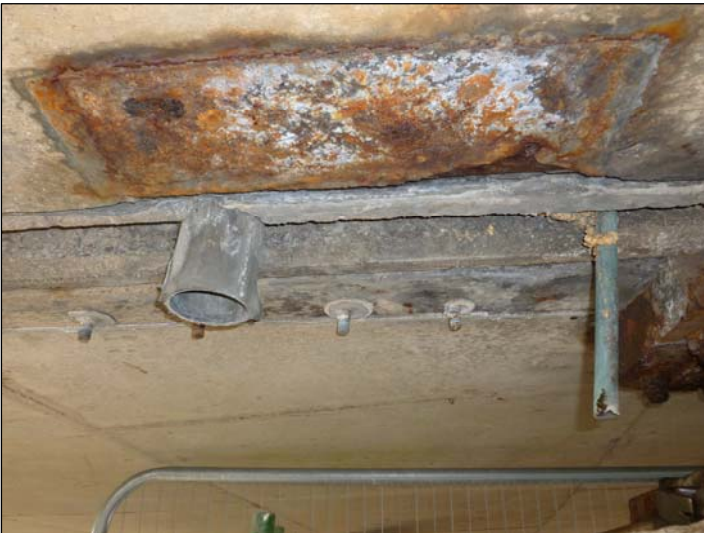
Adjacent to Bearing C1 & 2
One corroding steel plate has been left attached to the deck soffit adjacent to deck edge but similar plates have been removed from along the rest of the deck edge.

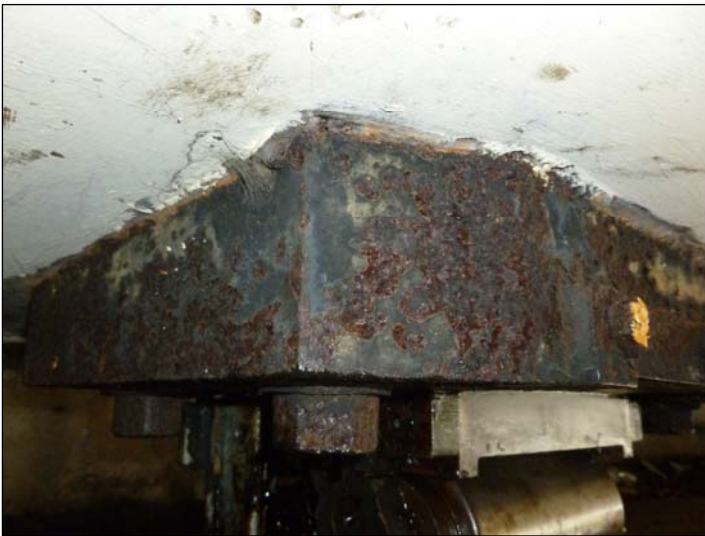
2.1.2.3. McAdam Way – Abutment

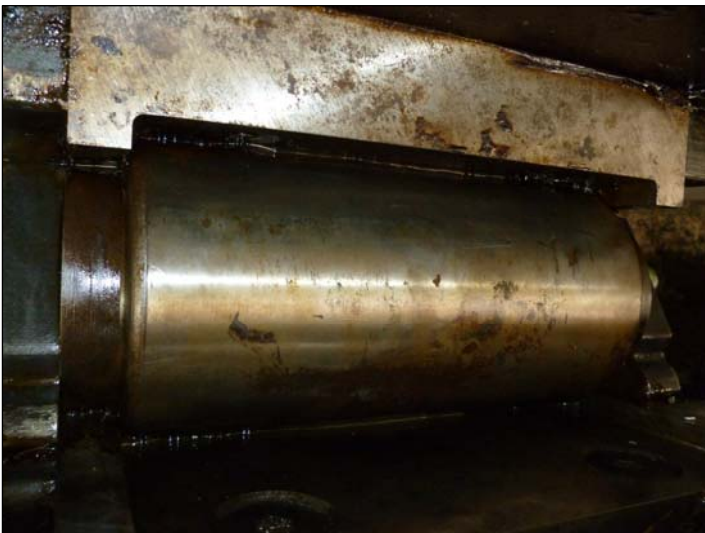
Moderate to heavy corrosion across steel plinth plates. Note no loss of section to nuts.

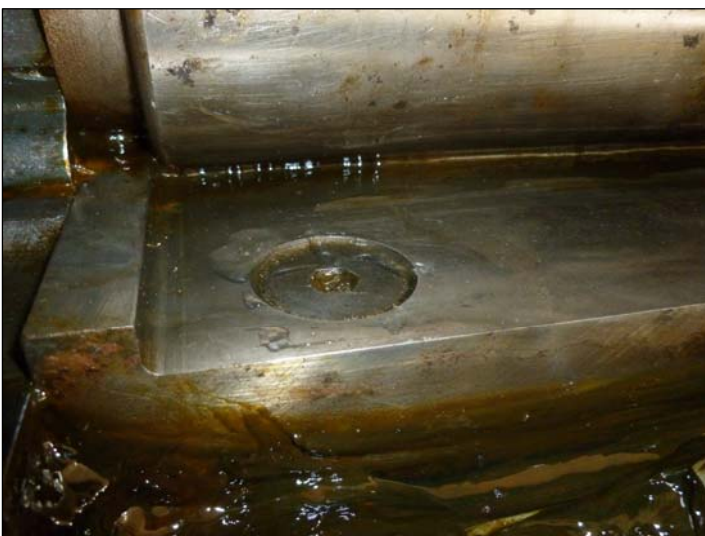
The rollers and top plates are in good condition with minor pitting and surface corrosion.

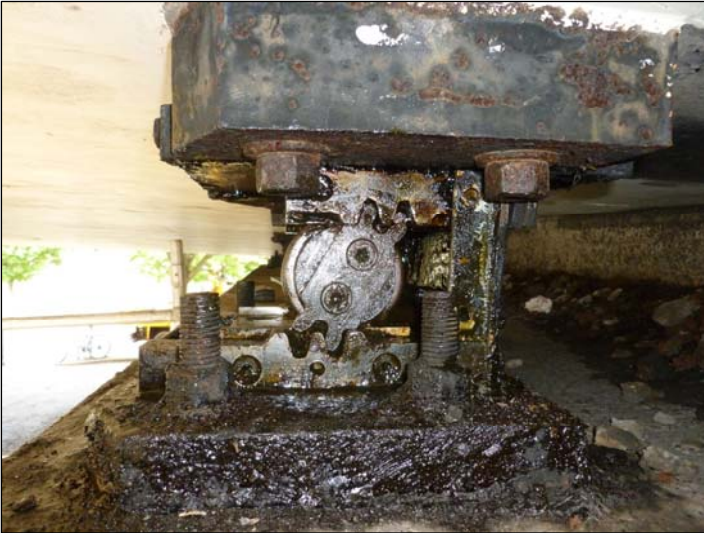
Bearing C;
We do not know at what angle the guides were set at but all three of the abutment bearings appear close to their limits of translation on the guides.

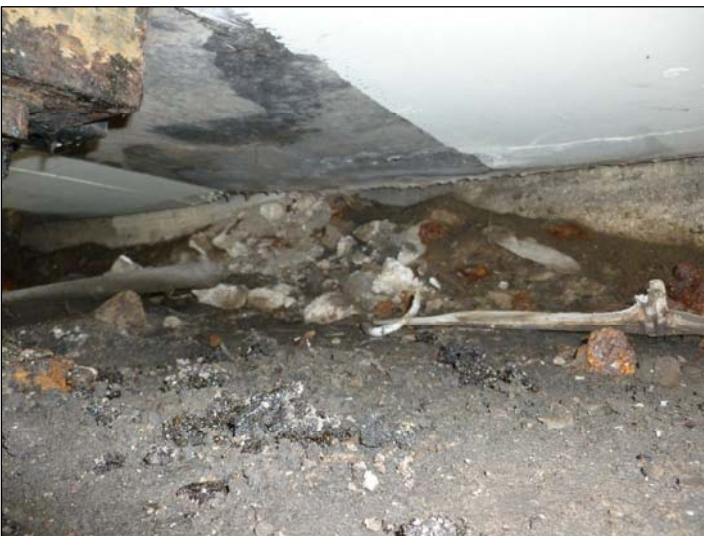
Adjacent to Bearing A;
Again, visible delamination of concrete along the deck edge. Also present along the back of the bearing shelf is a build-up of dirt and debris.

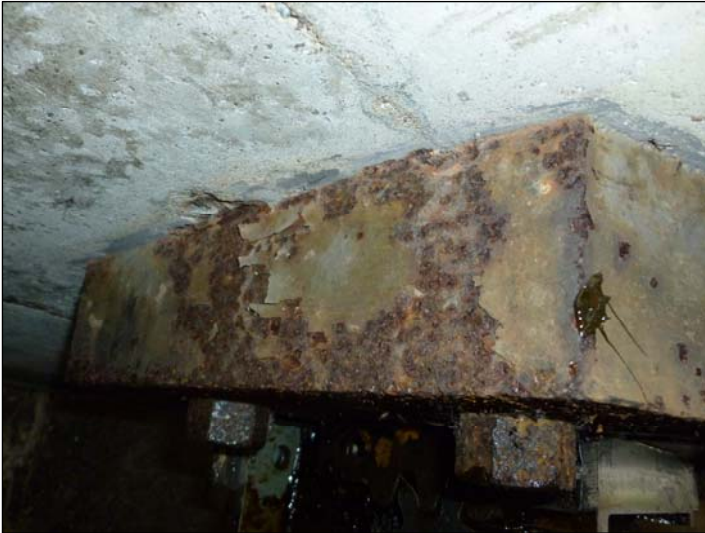
Bearing B;
Corrosion to steel top plinth with flaking paintwork and pitting to surface.

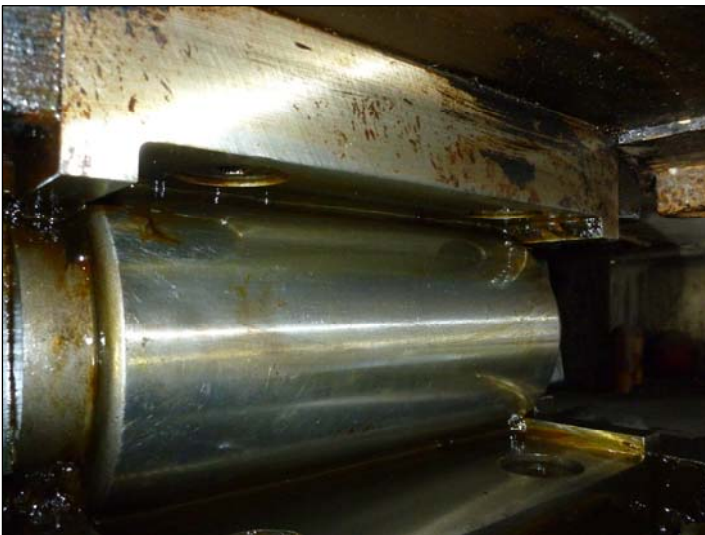
Bearing B;
Typical condition of the Ashmead Way abutment bearings are very good.

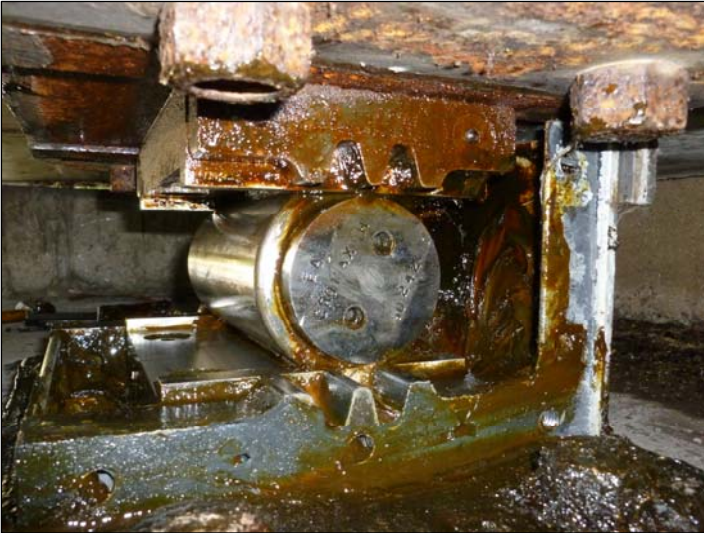
Bearing A;
End of roller bearing with roller guide removed for ultrasonic testing which is in good condition.

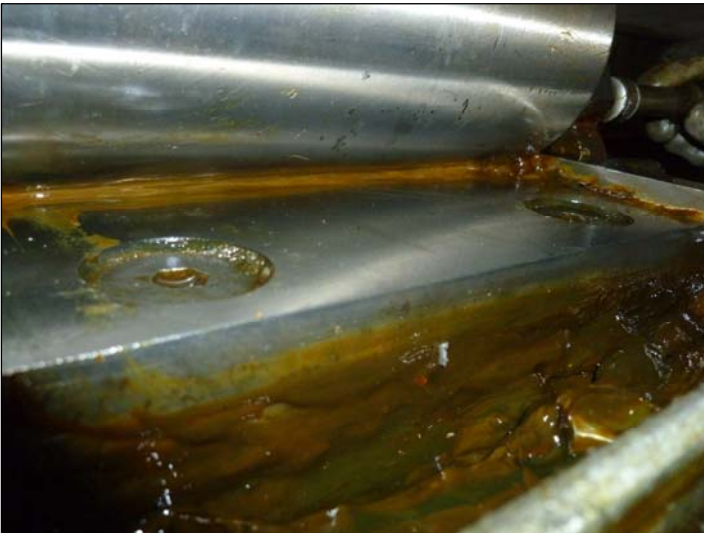
Bearing A;
The base plates and fixings are in good condition.

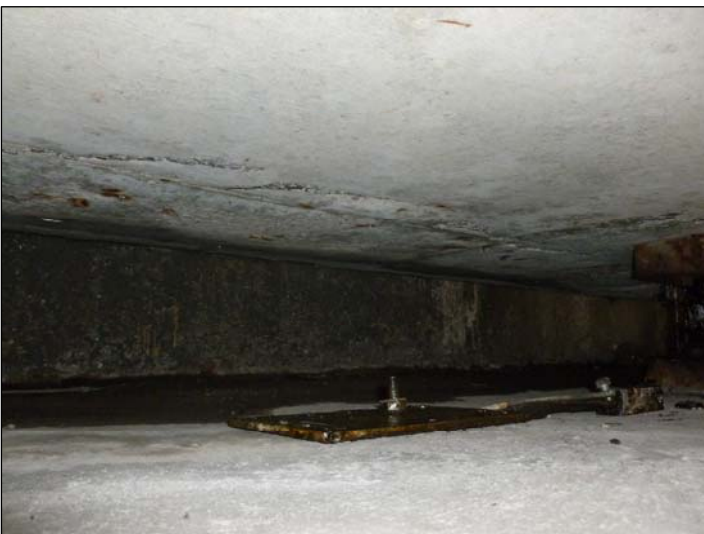
Adjacent to Bearing B;
There is delaminated concrete to the deck soffit adjacent to the deck edge.

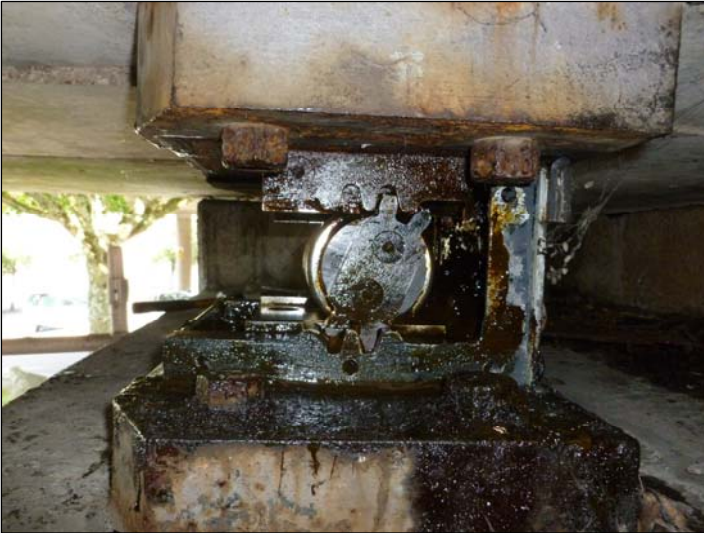
Bearing A;
The roller guide has been set to wrong position.

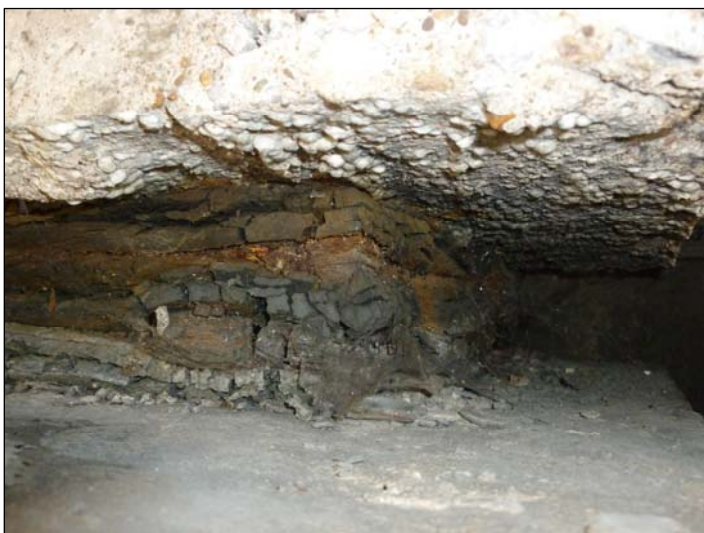
Bearing E;
The elastomerics are splitting and exposing corroded steel plates which are themselves delaminating.

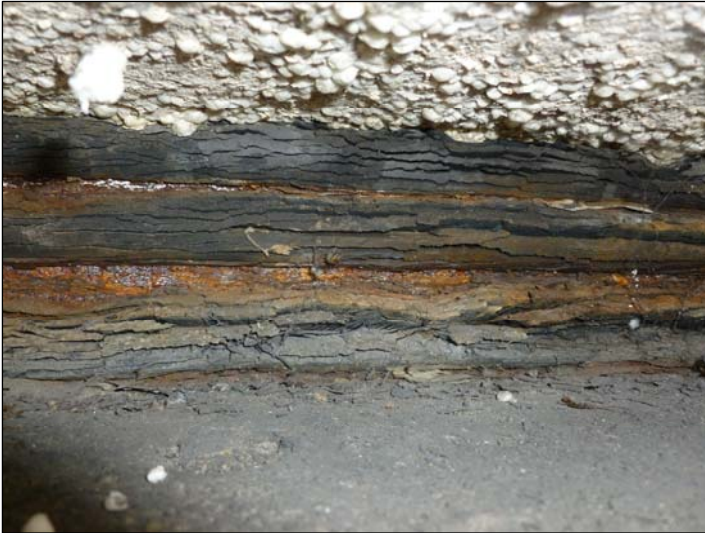
Bearing A;
Splitting of the elastomer and exposed
corroding steel plates.

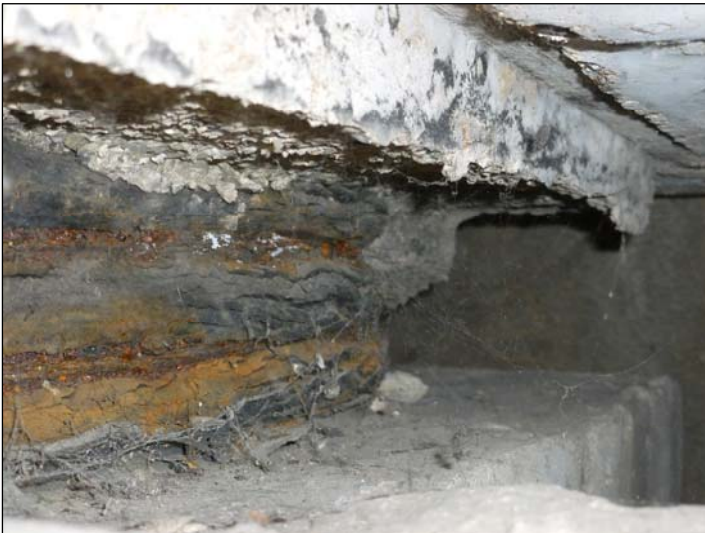
Bearing C;
Splitting and bulging of the elastomer and
exposed corroding steel plates.

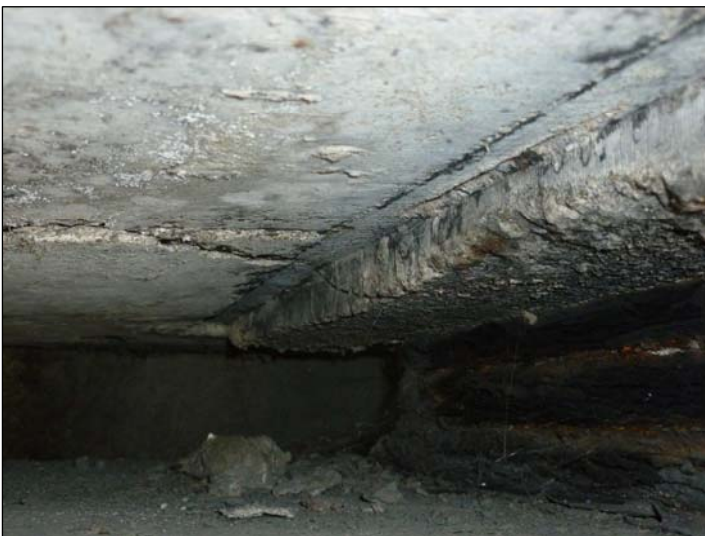
Adjacent to Bearing A;
Delaminated concrete to the deck soffit
and top plinth of bearing A adjacent to
the deck edge.

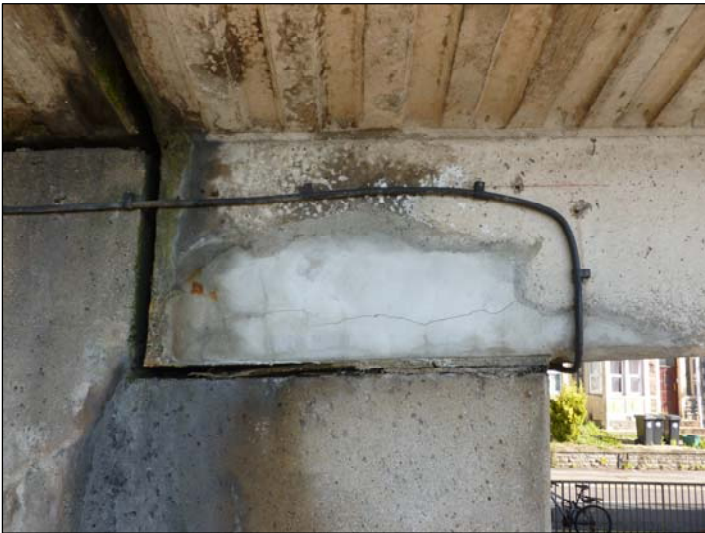
Above Bearing E;
Failed repair to the south end of the deck at abutment.

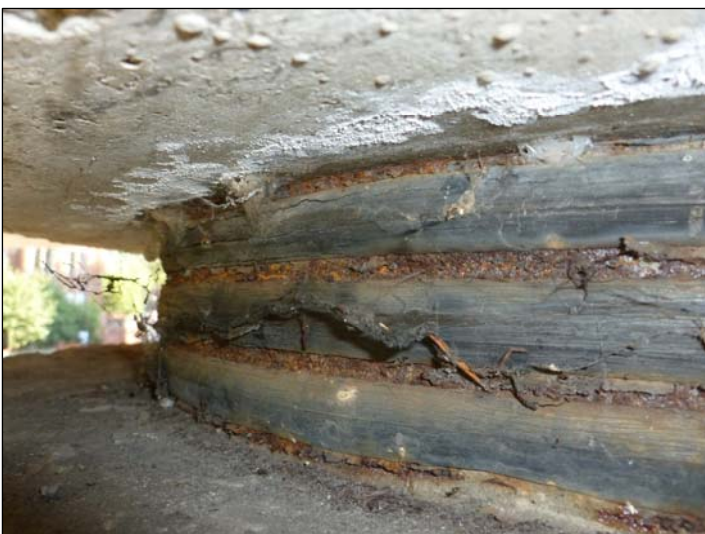
Bearing B;
Deterioration of bearing exposing corroding steel plates.

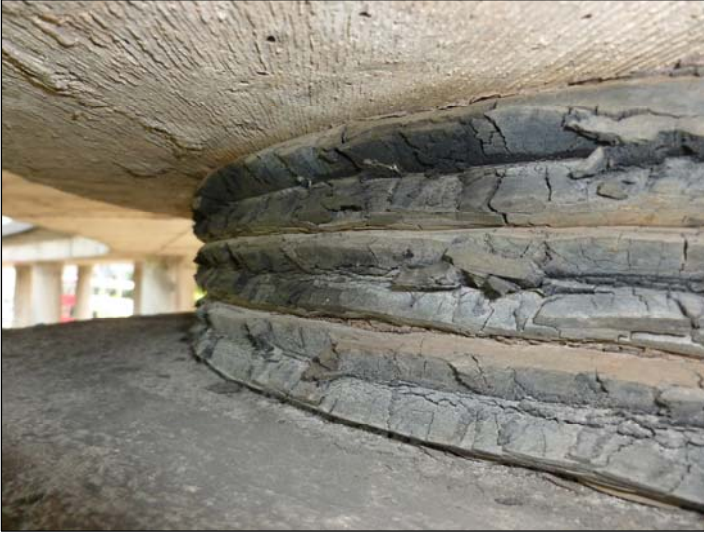
Bearing C;
Splitting of elastomer

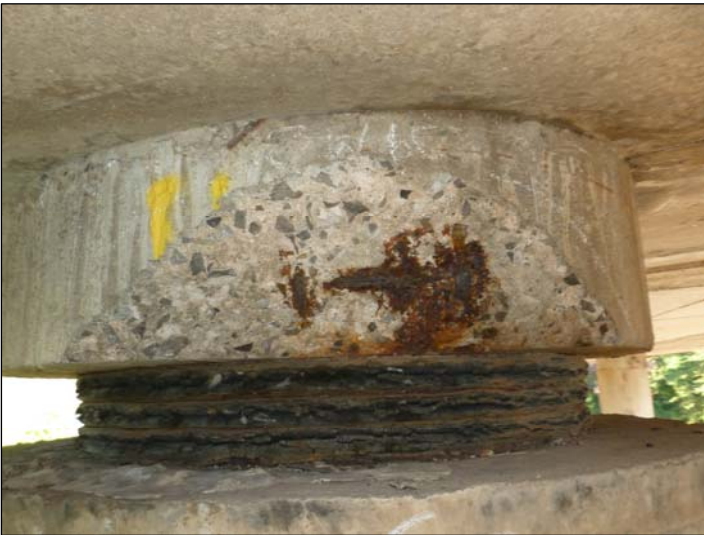
Bearing C;
Spalled concrete and exposed corroding
reinforcement to top plinth.

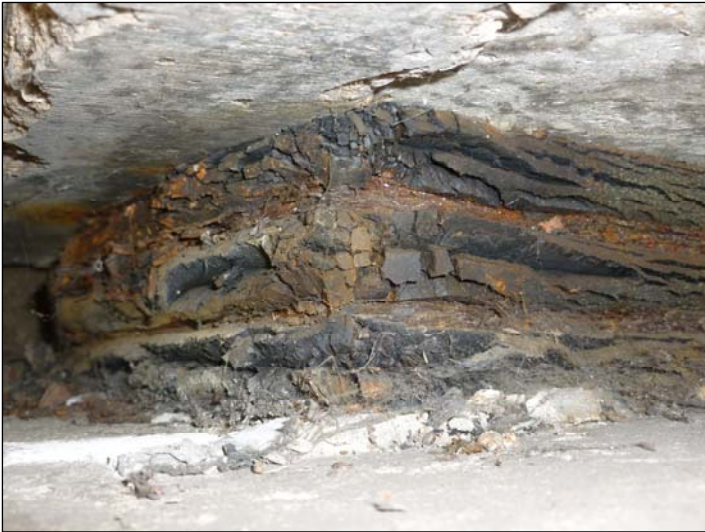
Bearing A;
Deterioration to the elastomer and
corrosion to exposed steel plates.

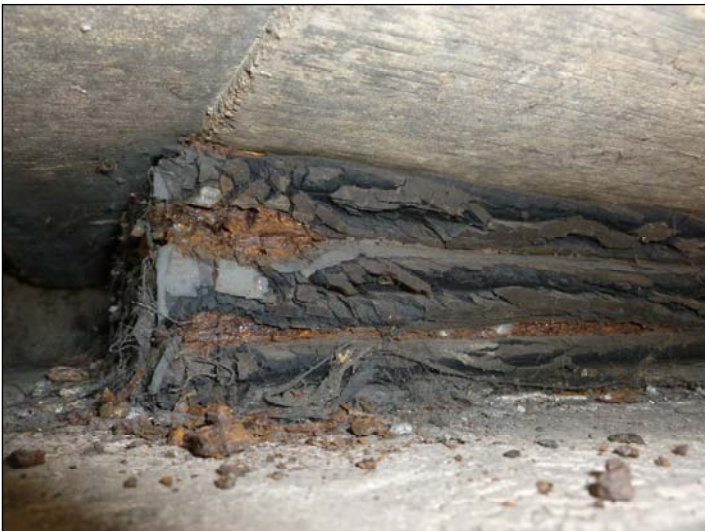
Bearing D;
Deterioration to the elastomer and
corrosion to exposed steel plates.

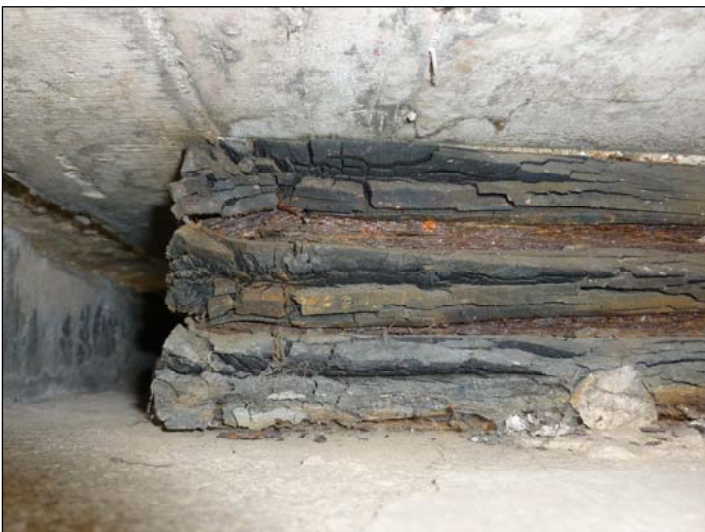
Bearing E;
Deterioration to the elastomer and
corrosion to exposed steel plates.

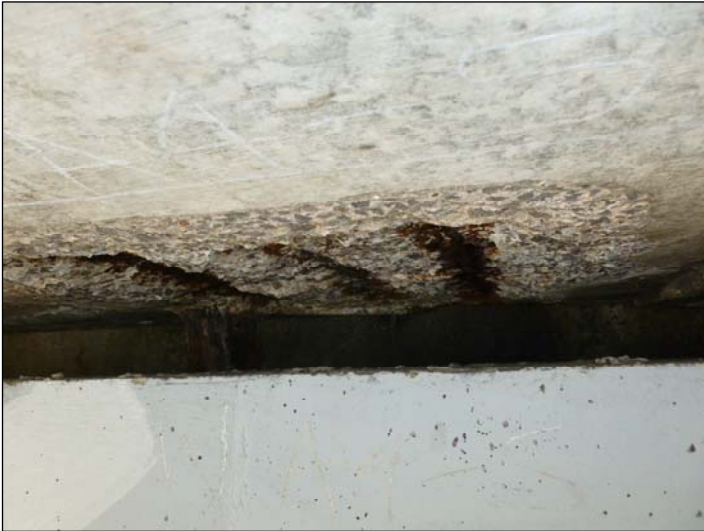
Between Bearings D & E;
Spalled concrete exposing corroded
reinforcement to the deck soffit.

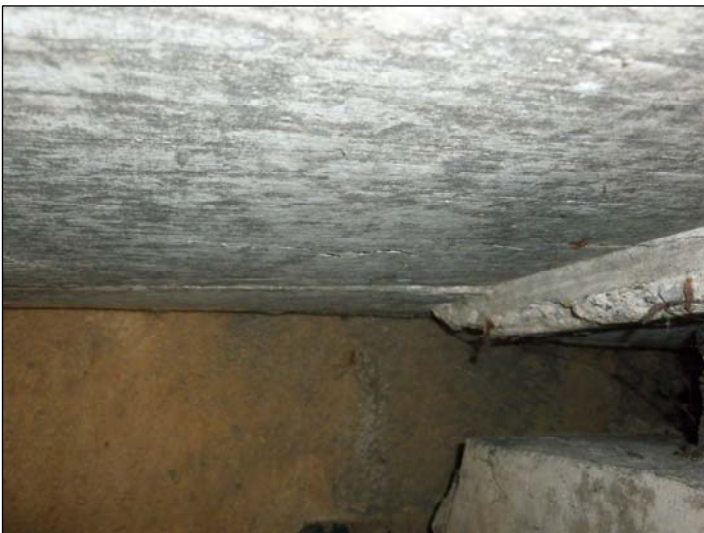
Between Bearings C & D;
Delaminated concrete to the deck soffit
adjacent to joint.

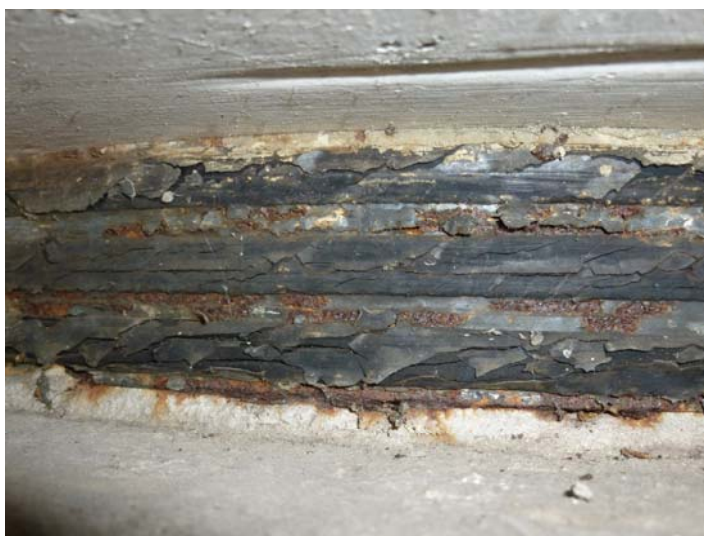
Bearing B;
Deterioration of elastomer, exposing steel
plates which are corroded.

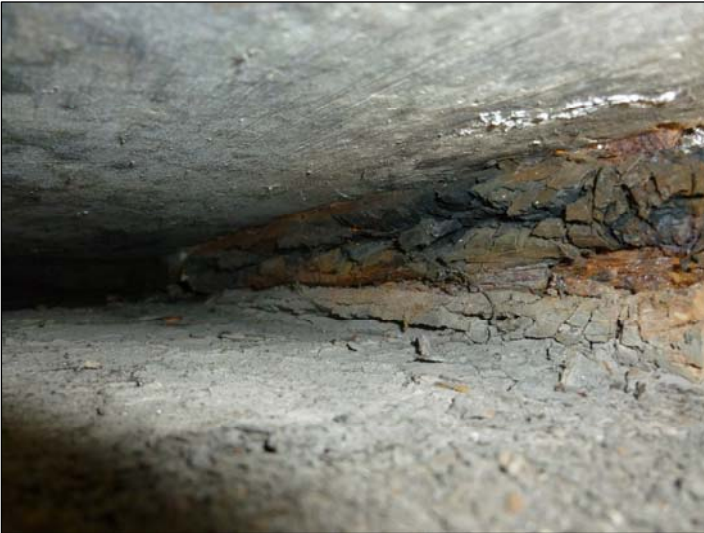
Bearing A;
Cracking to elastomer and corroding steel plates.

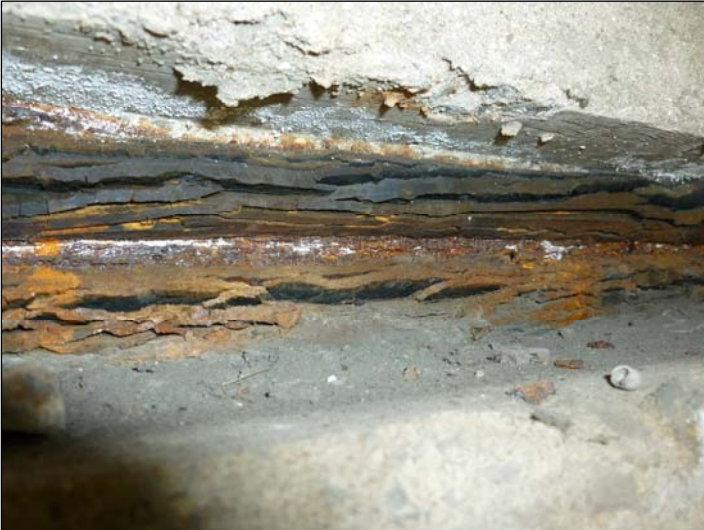
Bearing C;
Cracking to elastomer and corroding steel plates.

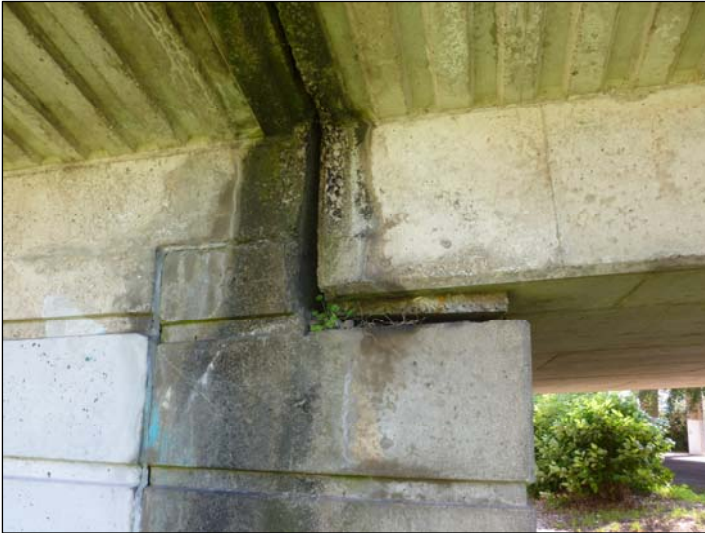
West End of Abutment, Adjacent to Bearing D;
Heavy water staining around and below the joint.

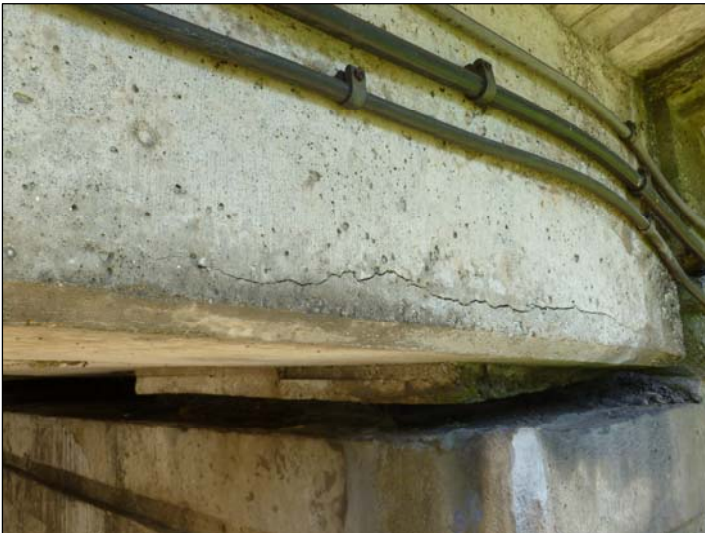
Deck Edge Adjacent to Bearing A;
Reinforcement corrosion crack along deck edge.

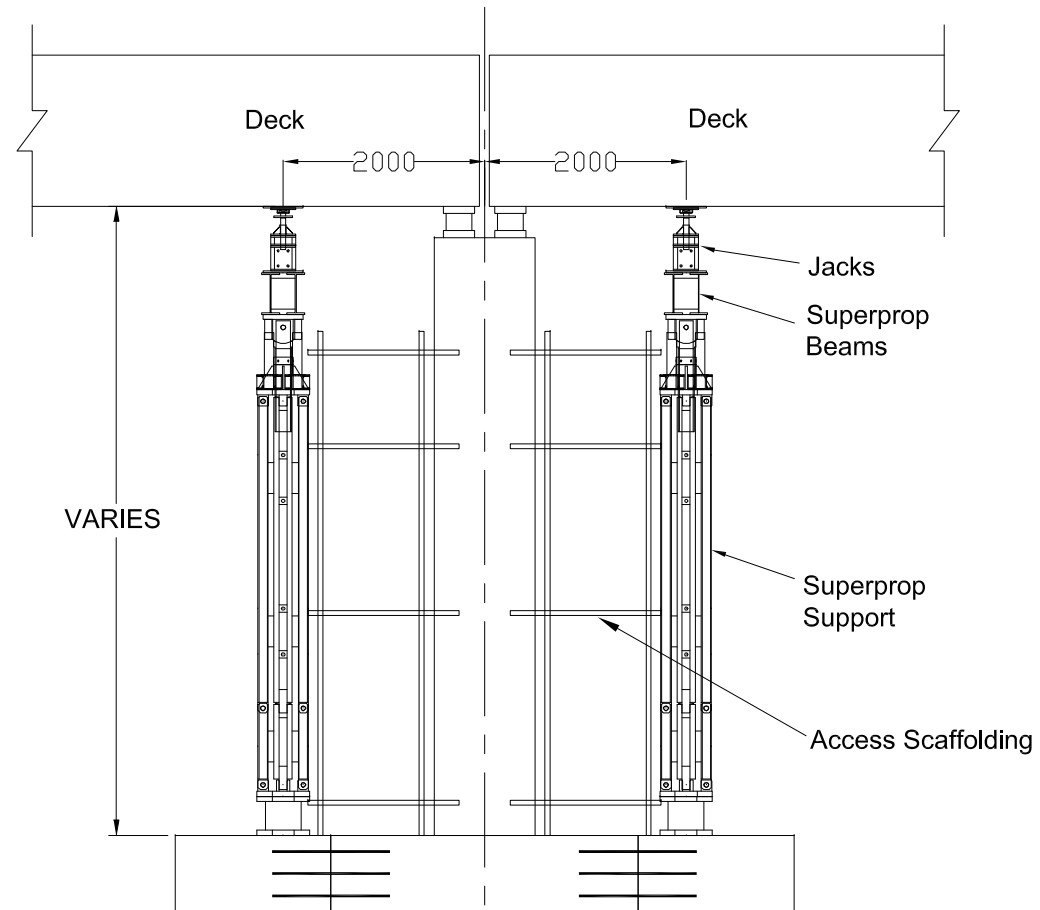
Elevation
Scale 1:75
